CIRCULAR NO. 28/16

LOSS PREVENTION: SLIPS, TRIPS AND FALLS

Wise up before you rise up!

Fix it before the fall!

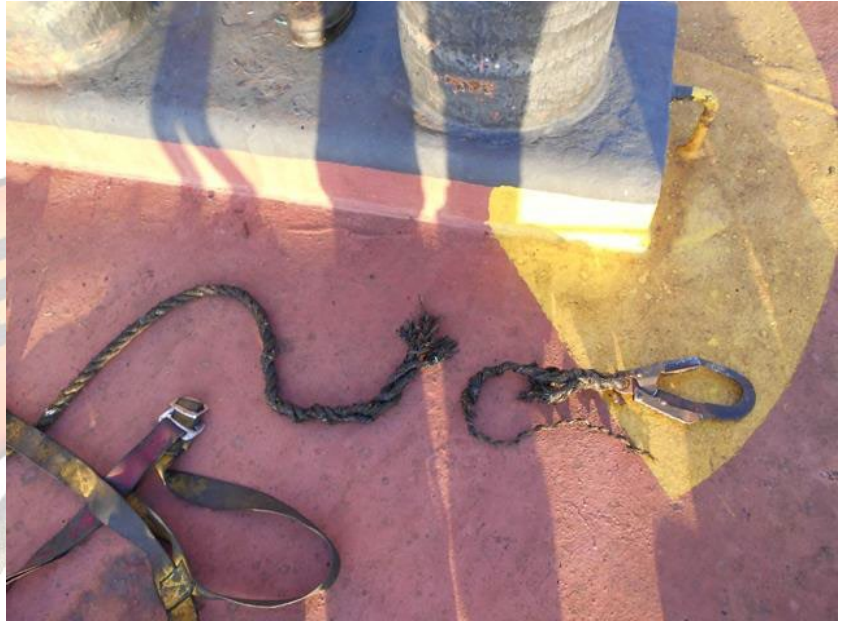
Description of Incident: During routine maintenance work aloft while at sea, a 41 year old able bodied seaman was seriously injured after a near fatal fall from a height of 13 feet (4 meters) onto the cross deck. The fall was ultimately determined to be the consequence of the lanyard on his fall arrest equipment breaking under tension. The safety harness was found to be overused and had gone unchecked as evidence had shown upon review of the maintenance records for life saving appliances.

Actual Injuries: *The seafarer sustained multiple fractures to his pelvis, left wrist, ribs and a ruptured spleen.* The injury to his pelvis required both surgical and external stabilization.

- *Use a full-body harness with a shock-absorbing lanyard or a retractable lifeline.* A full-body harness distributes the fall forces throughout the body and reduces the chances of injury. A “body belt” fall protection device concentrates any fall related forces into the abdomen area. The shock-absorbing lanyard decreases the total fall arresting forces.
- *Only rig a full body harnesses and use fiber lines intended for use as personal fall arrest equipment.* Only personal fall arrest equipment designed for use should be used for working aloft.

- *Incorporate visual checks and inventories of personal fall arrest equipment into your regular safety equipment inspection regime. Inspect harnesses and shock cords regularly as a part of the normal safety equipment check routine. Ensure they are in proper condition, free of wear and tear, and clean and ready for use.*
- *Personal fall arrest equipment found to be damaged, heavily worn, or overused should be removed from the inventory to ensure it is not mistakenly used by the crew.*

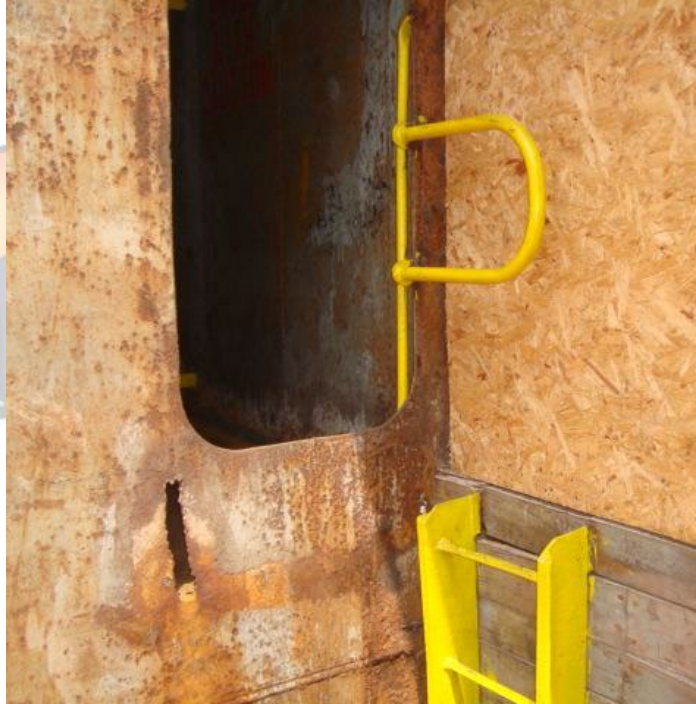
This incident resulted from the stevedore having grasped a weakened wooden batten board at the top of the ladderwell that broke while trying to climb off of the ladder. At the time of the incident, the ladderwell configuration offered no better option to hold onto at the top of the ladder.

A few months later, a similar incident transpired. In this instance, a 54 year old stevedore descended into cargo hold no. 2 and fell from the fixed ladderwell platform. As in the prior incident, it was discovered that the ladderwell hold design and configuration did not provide sufficient hand holds at the top of the ladder to prevent his falling. Eventually, modifications were made in order to ensure that grip bars above the ladder were installed above the ladder as seen in the figure.

- *The crew should inspect cargo hold access areas prior to cargo operations and only present the vessel in a condition that stevedores can load and discharge the cargo with reasonable safety.* Ladder's standing platforms, grip bars, rungs/treads, railings are free of dust, cargo debris, oily or greasy surfaces or any other condition that can cause a slippery condition.
- *Any latent hazards discovered by the crew are best corrected and repaired prior to commencement of cargo operations.* If any of the ladder's standing platforms, grip bars, rungs/treads, railings, etc. are in disrepair, do not use the ladder until it is fully repaired.
